CHICAGO PARK DISTRICT

COMMUNITY CENTER PARK

COMMUNITY MEETING

19 September 2019

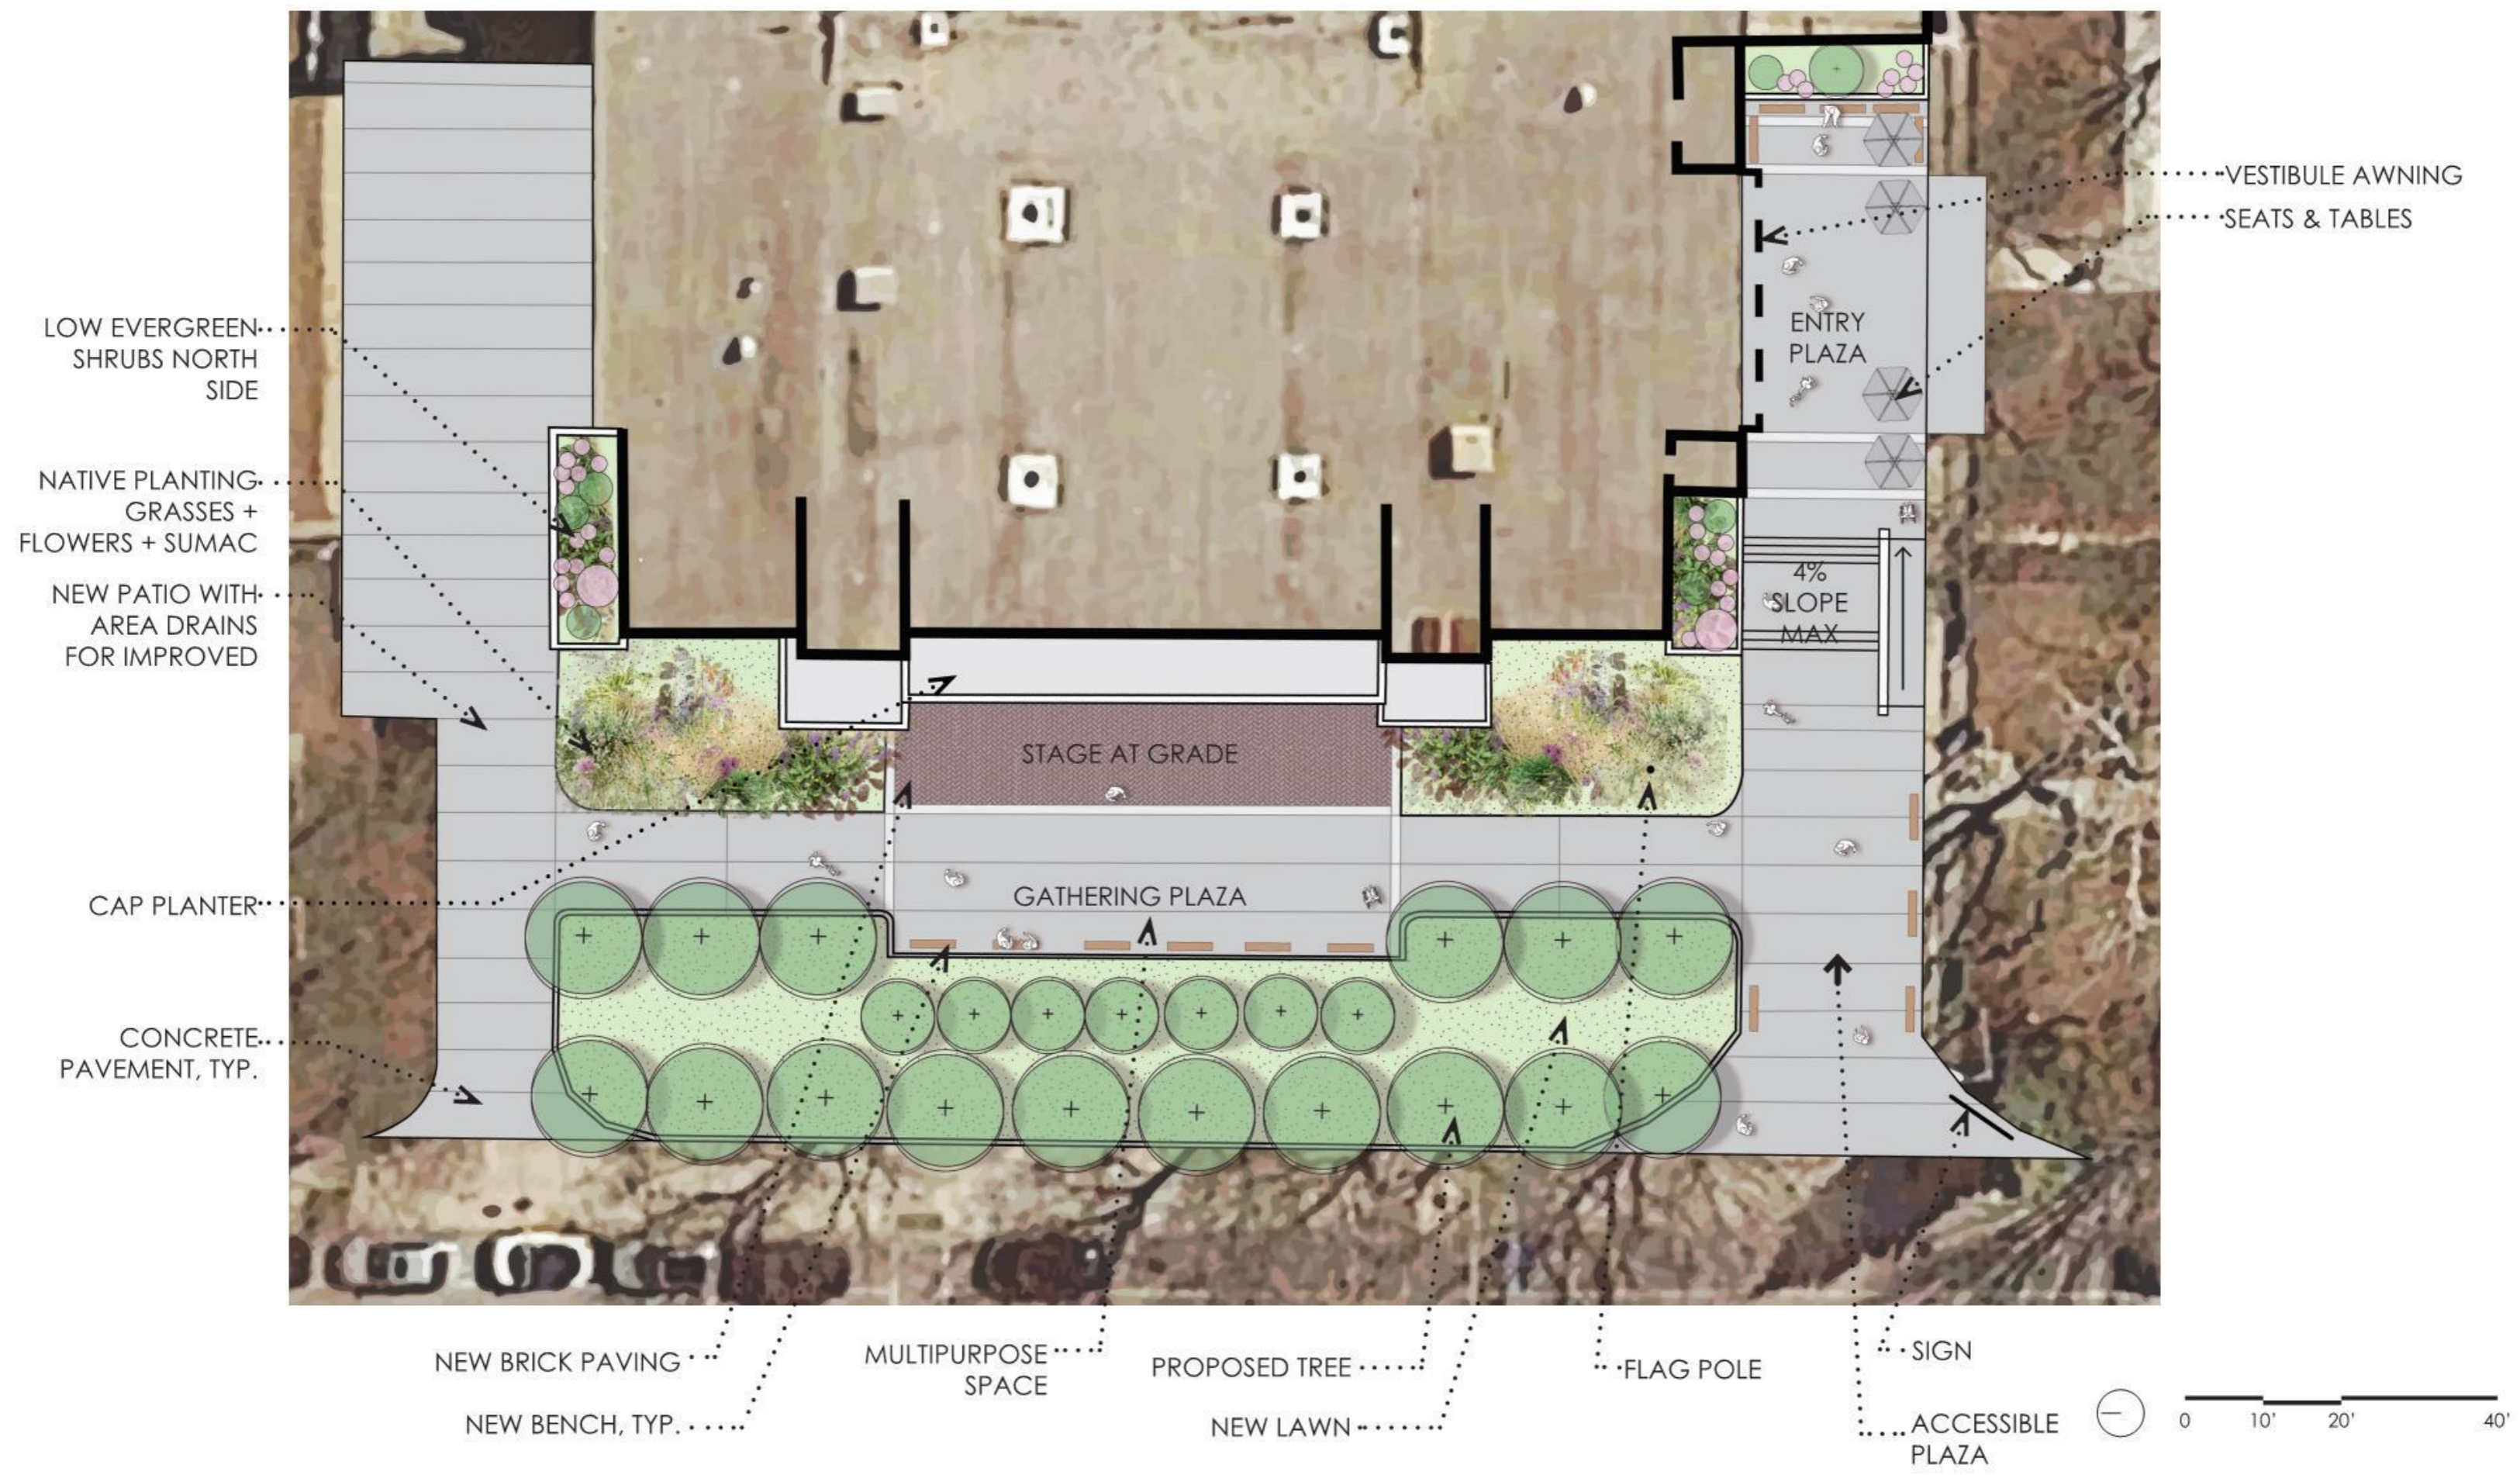
Improved Drainage

PROPOSED STORM SEWER CONNECTION TO CITY MAIN

EXISTING PATIO AREA PRONE TO FLOODING

EXISTING STAIR TO GYM PRONE TO FLOODING

PROPOSED STORM SEWER AND CATCH BASINS

EXISTING ENTRANCE PLAZA PRONE TO FLOODING, CONNECT TO EXISTING STORM SEWER LINE ON SITE

CLARENDON PARK COMMUNITY CENTER FLOODING REMEDIATION

Site Work – Mitigate flooding issues with area drains and new storm line at entrance areas, new concrete sidewalk where are drains installed and new hardscape at new entrance

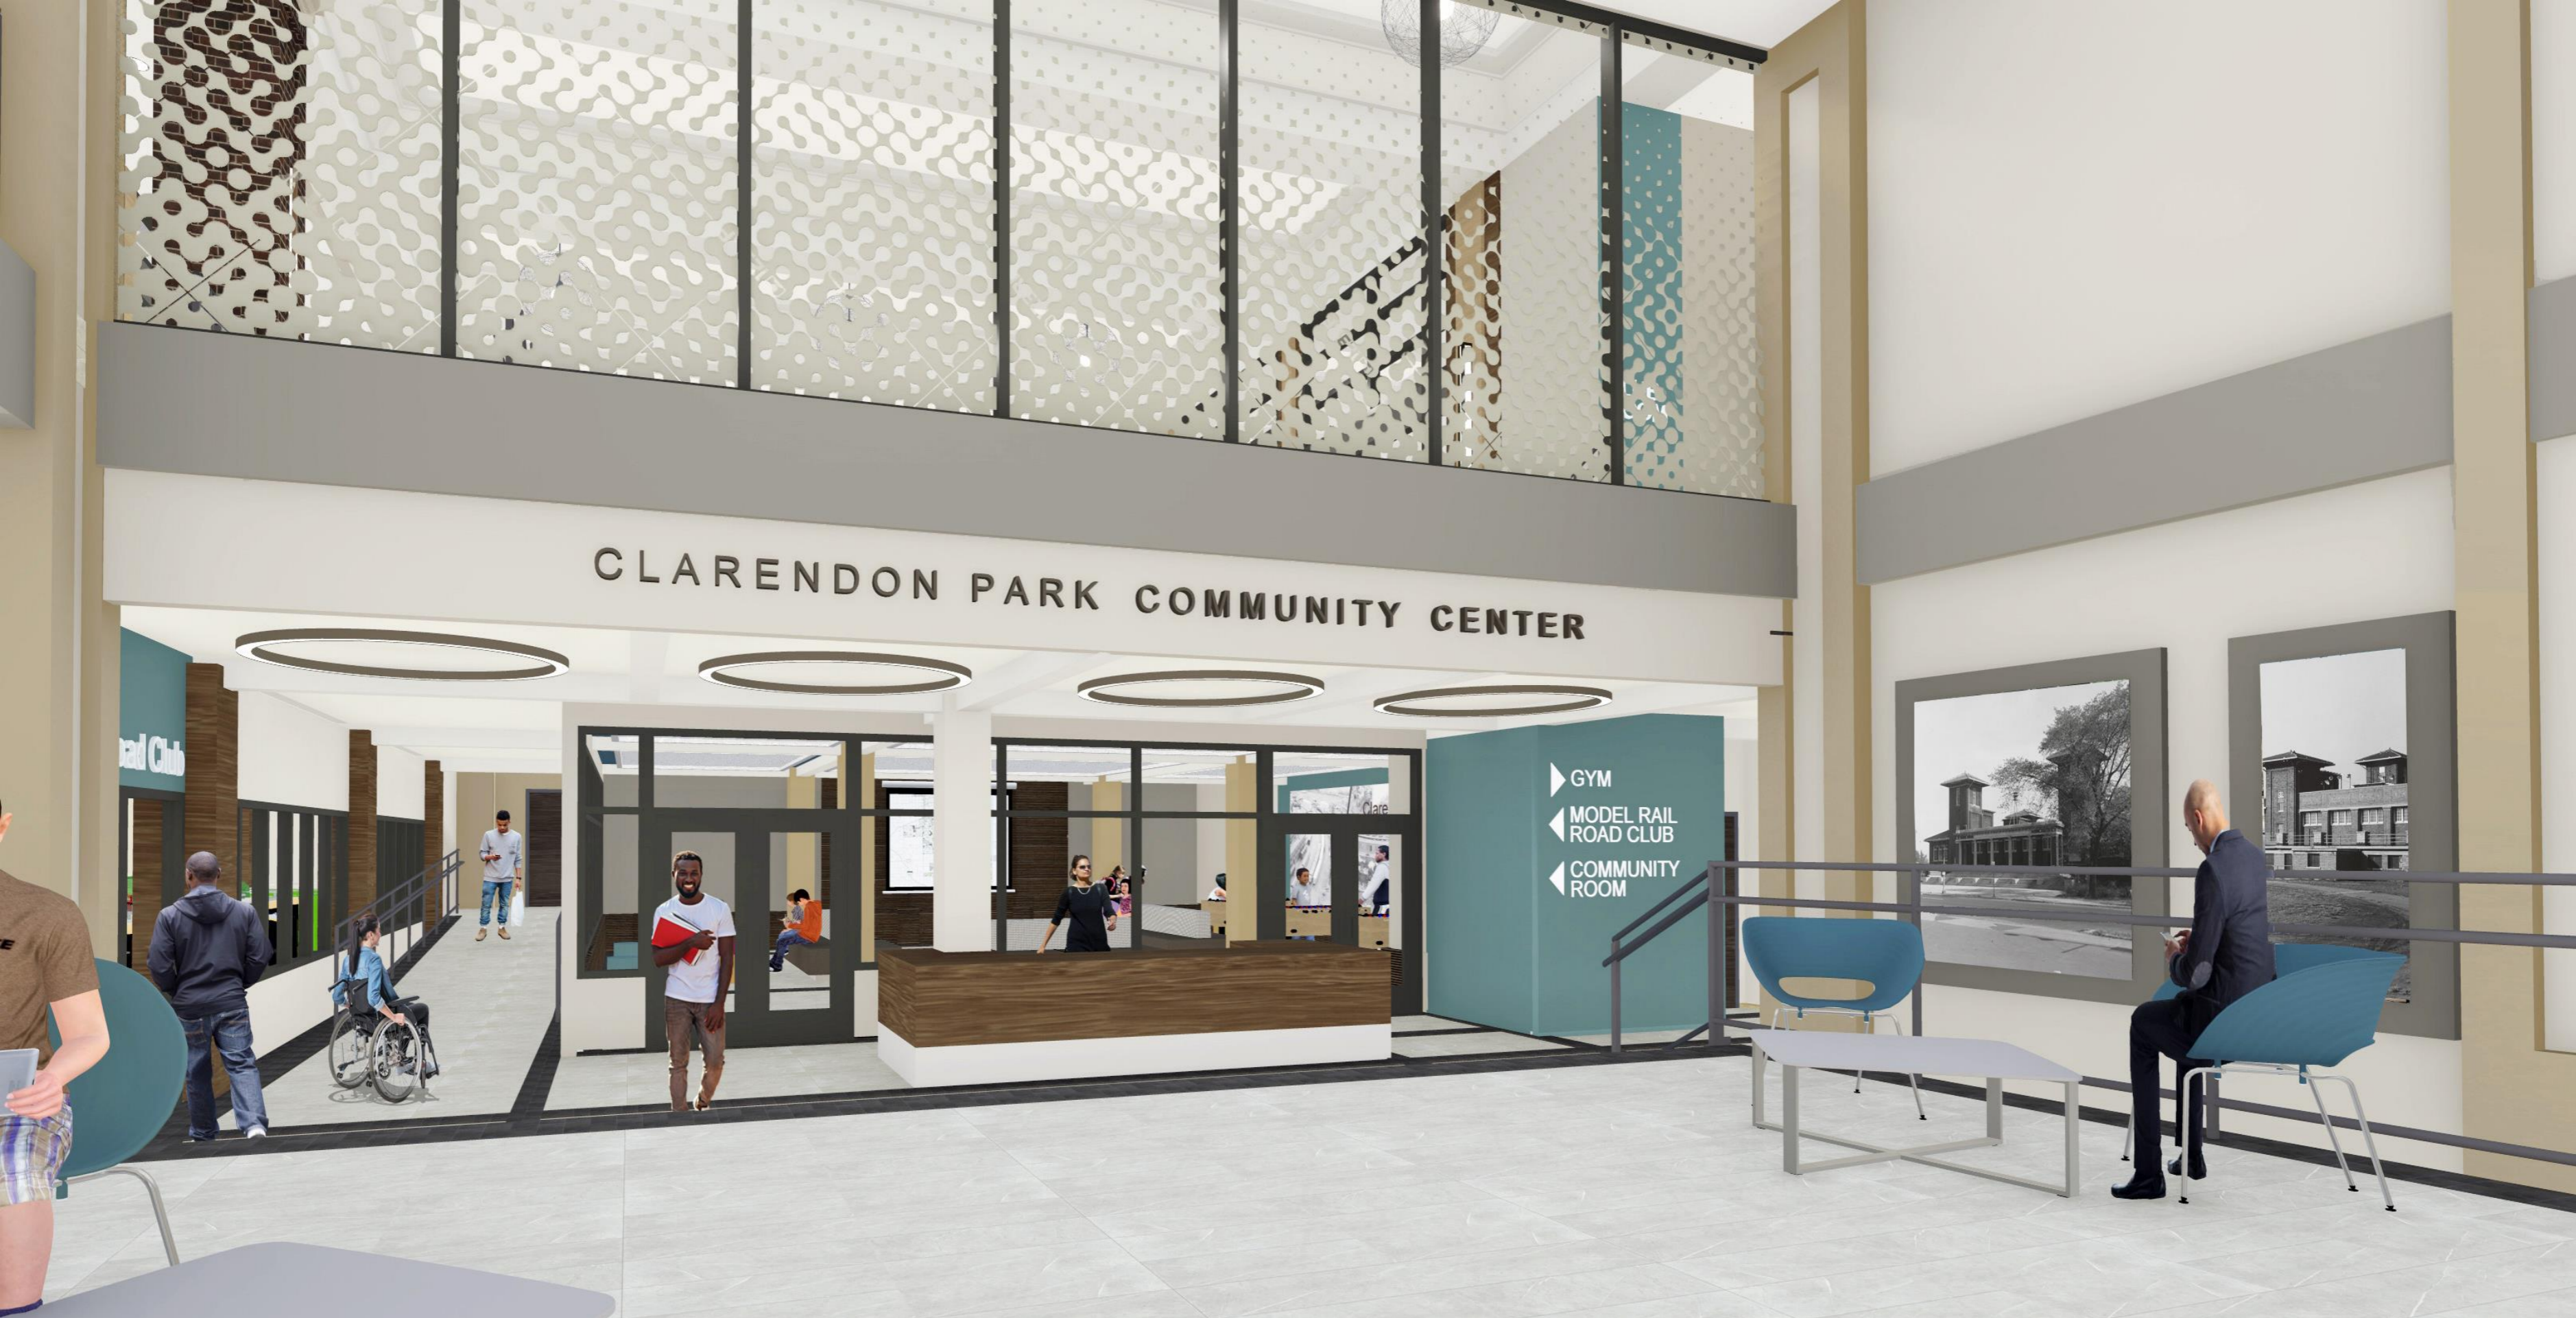
Ground Floor - Lobby

- ▶ GYM
- ◀ MODEL RAIL ROAD CLUB
- ◀ COMMUNITY ROOM

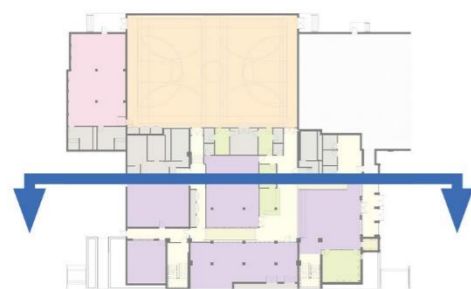
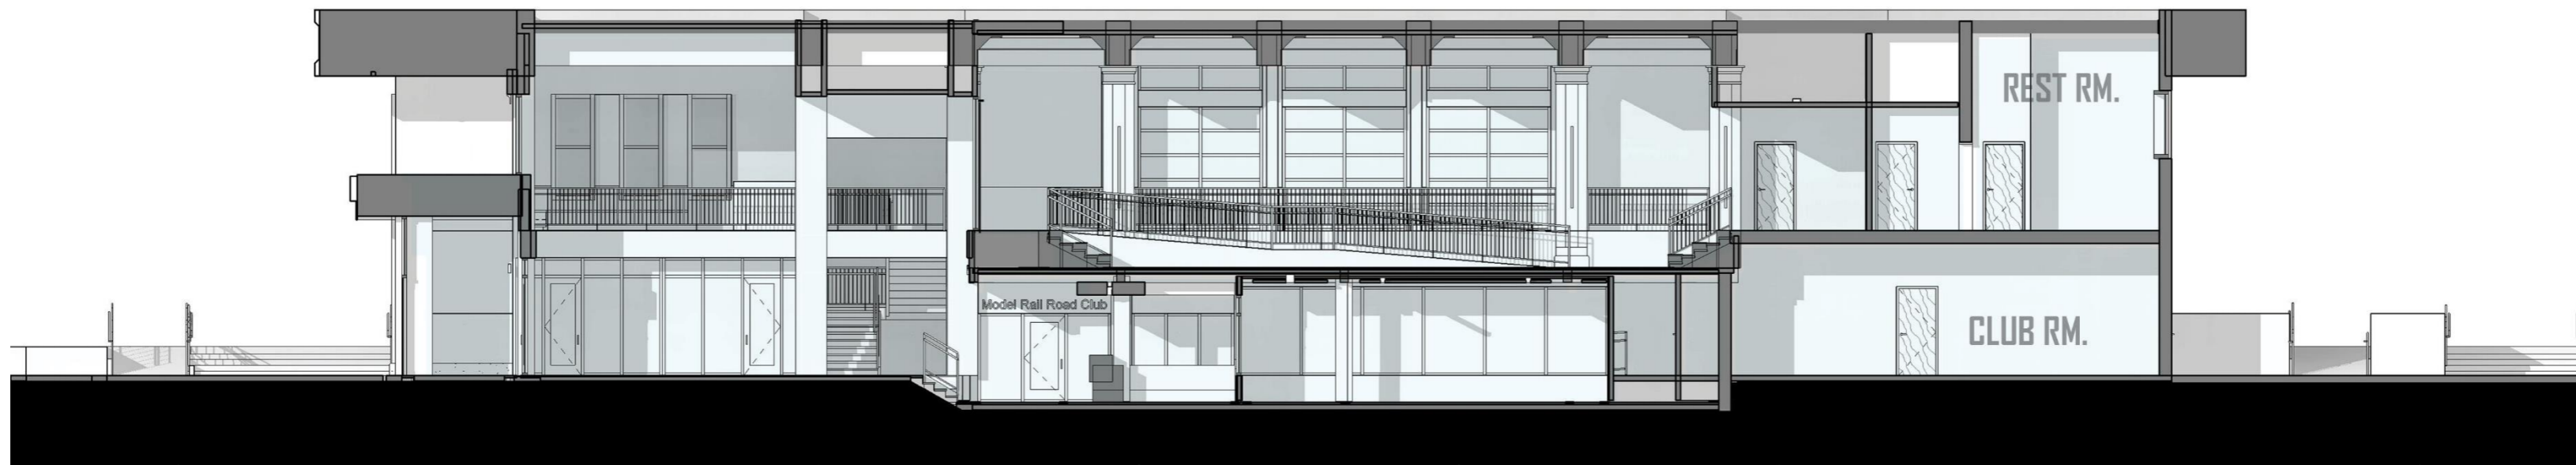
Building Section

LEVEL 2:

VEST.

LOBBY / LOUNGE

CENTER MAKER SPACE

EXISTING PROGRAM

LEVEL 1:

LOBBY / GATHERING

RECEPT.

PROGRAM ROOM

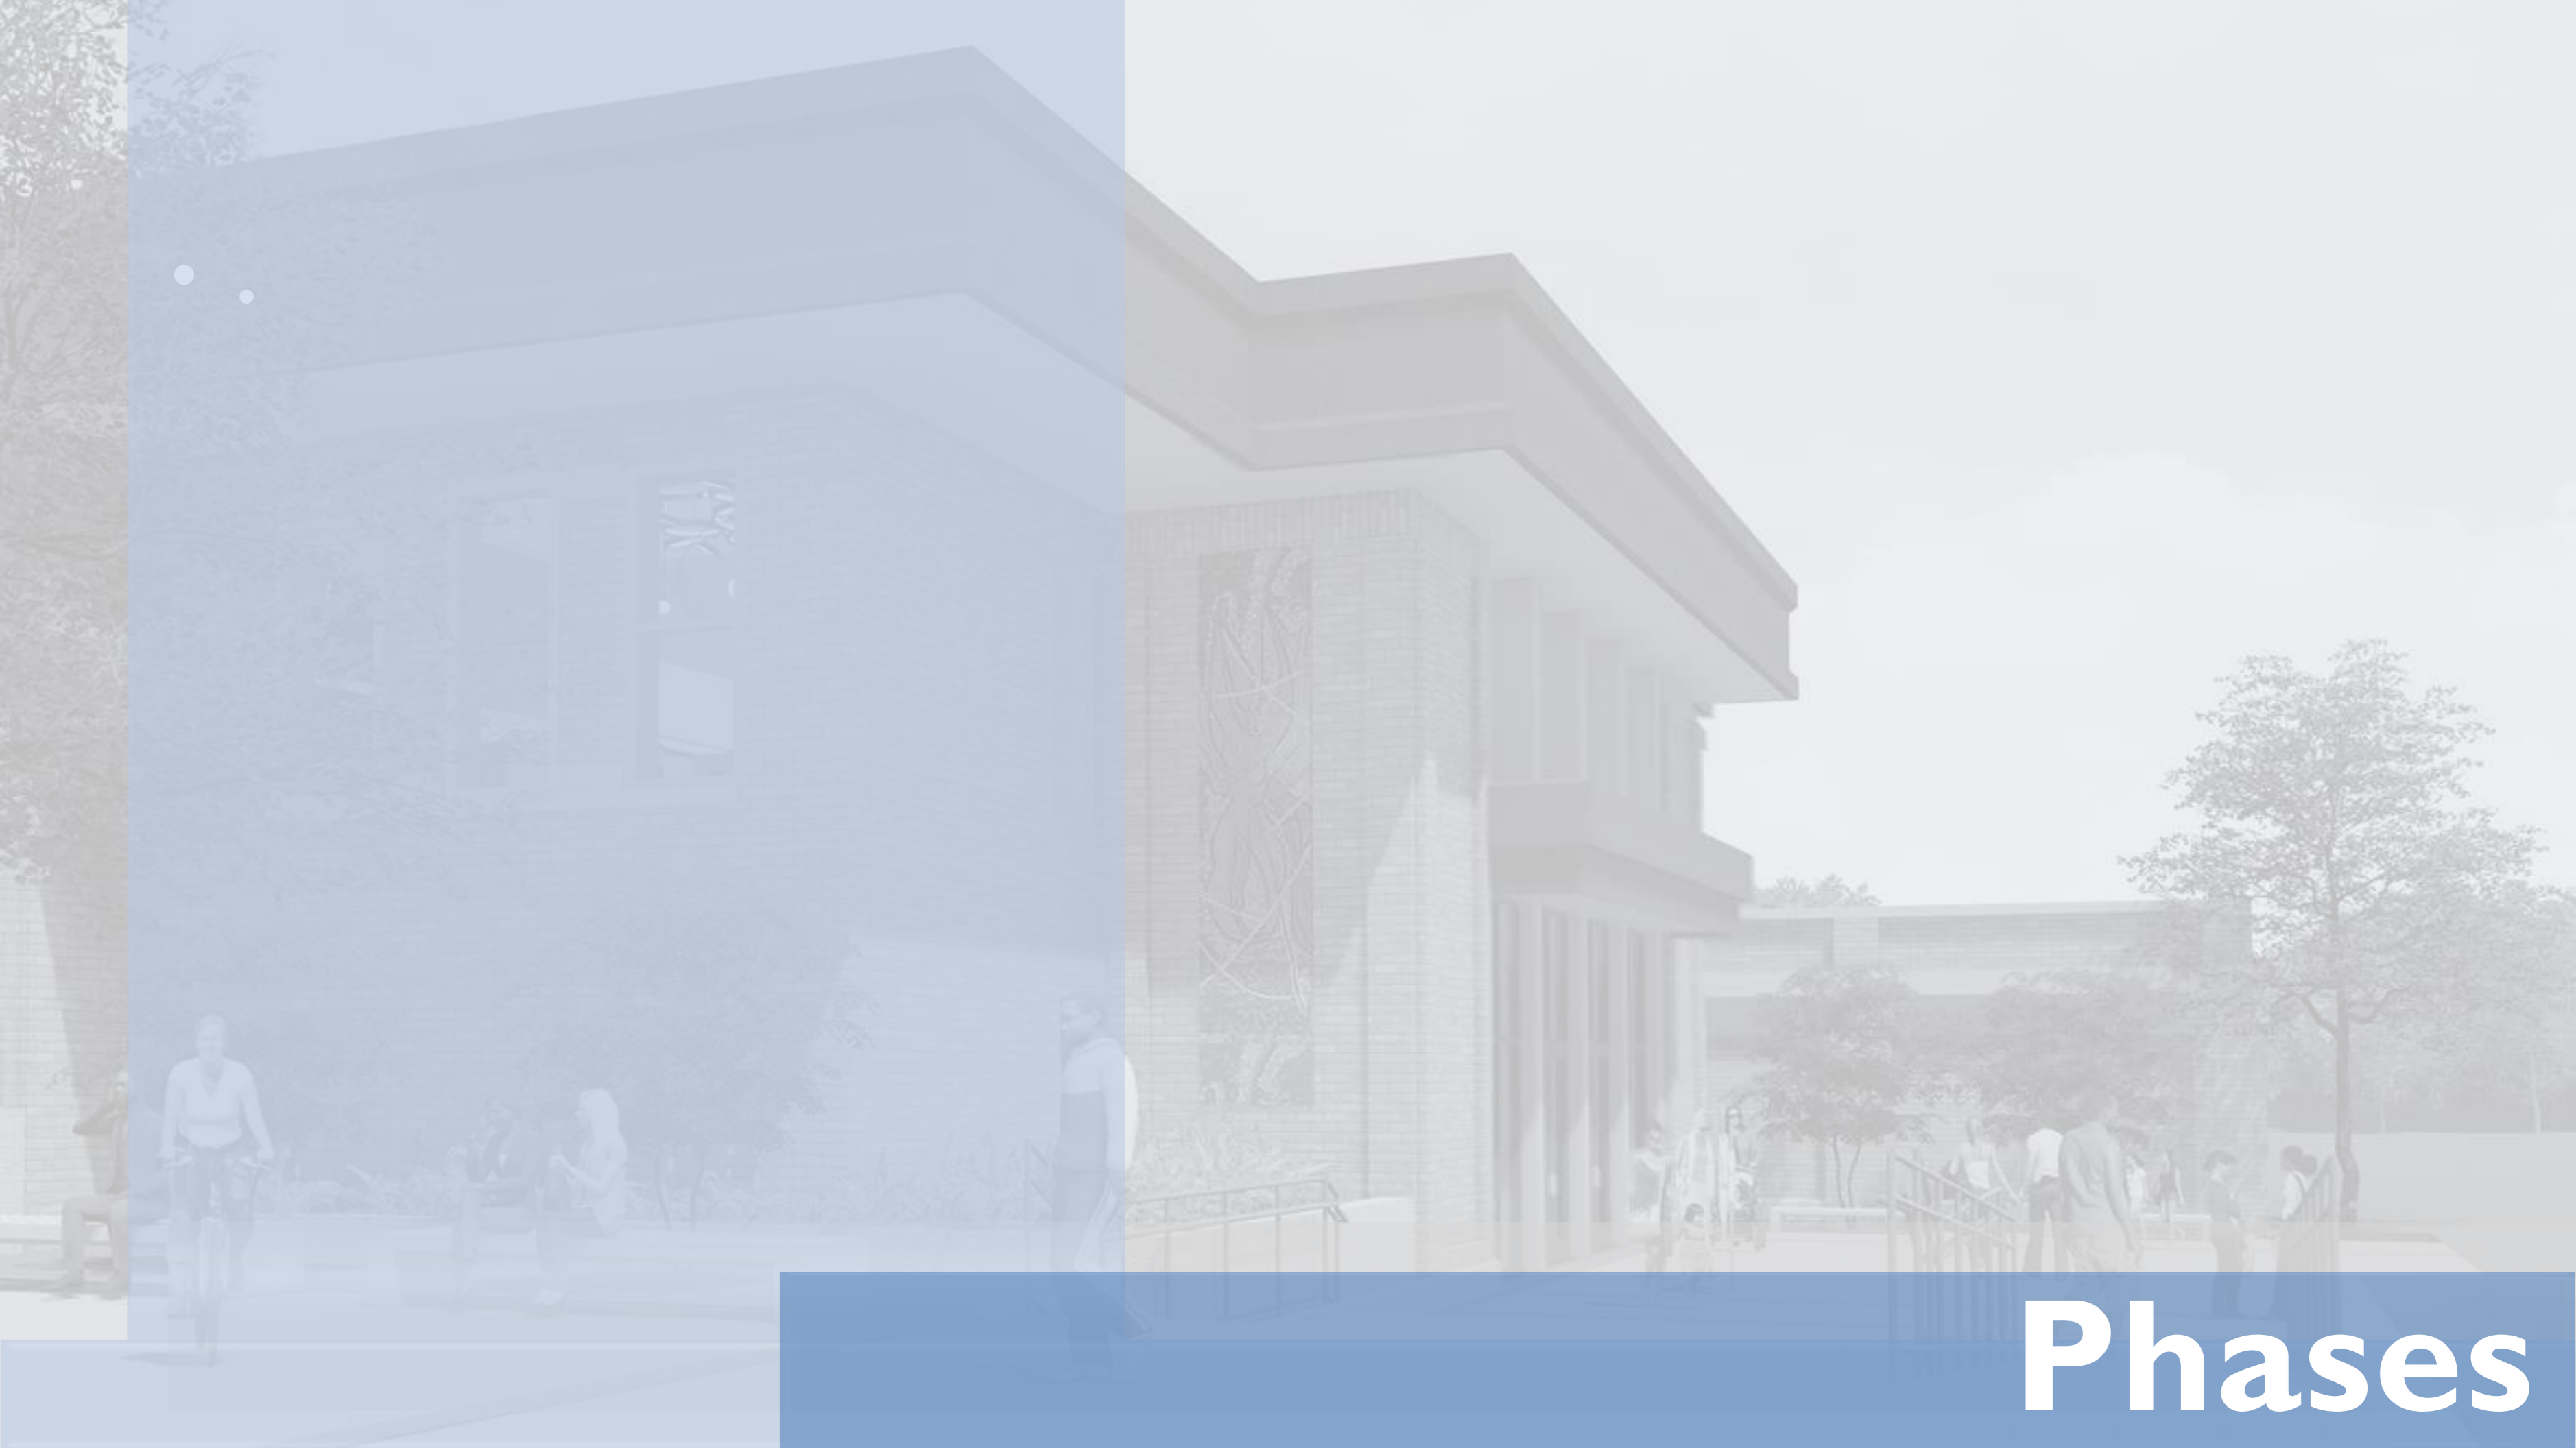
Phases

REPLACE ALL WINDOWS WITH ENERGY EFFICIENT DOUBLE PANE WINDOWS

REPLACE METAL FASCIA AND SOFFIT COMPLETE

MASONRY REPAIR- TUCKPOINT AND REPAIR EXTERIOR FACADE

SITE- REMOVE EXISTING LANDSCAPING, REPAIR PLANTERS AND CAP

Re-Roof Scope (1 Upper & 2 Lower Roofs) -Replace entire roof and insulation with new R30 insulation and 80mil PVC roofing

Metal Fascia -Replace Metal soffit and fascia 100%, existing framing to remain, replace any damaged members

Limited Ceiling Repair (25%) - Replace any water damaged ceilings after new roof is in place

Planter - Remove existing landscaping, repair, waterproof and cap planters

Exterior Masonry & Concrete Foundation Wall Repair –Tuckpointing for the entire building, repair/replace of damaged masonry, repair damaged foundations

Transformer & Switchgear- Replace the existing ComEd transformer with new exterior transformer, replace existing switchgear in the same location

Mechanical Reno Allowance – Repair and rework existing HVAC to renovated and remodeled spaces

Optional but Recommended MEP – Install Air Conditioning through out the building

Replace Windows– Replace all exterior windows with energy efficient double glazed windows.

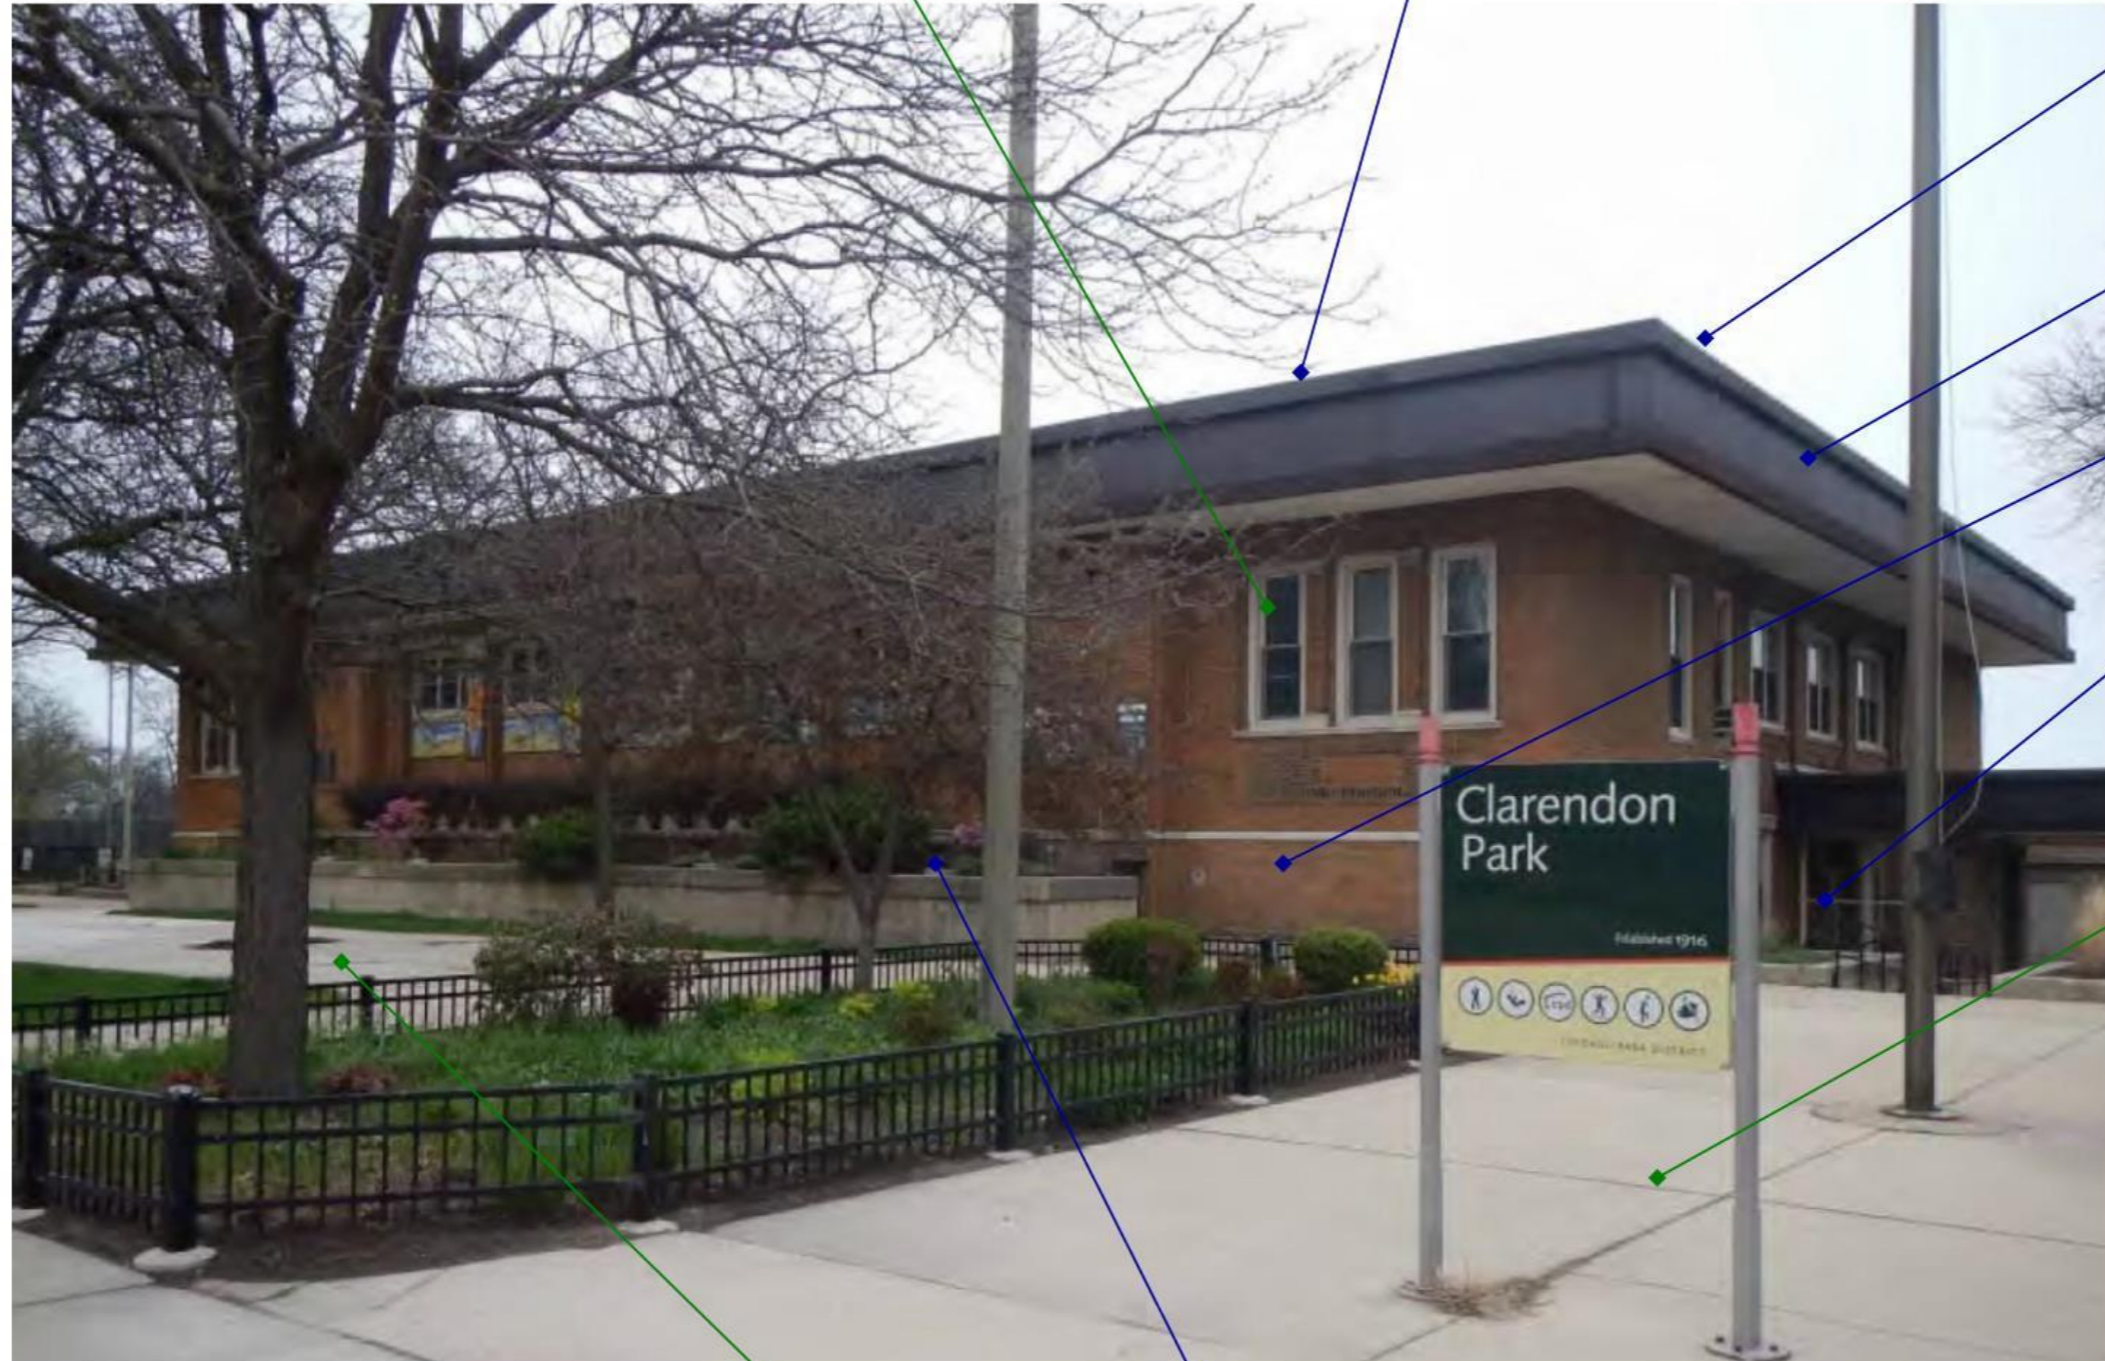
GYM-NEW CLERESTORY WINDOWS AT GYM (BEYOND)

RE-ROOF-NEW INSULATED ROOF WITH DOWN SPOUTS AND GUTTERS FOR GYM ROOF

NEW ADDITION- 2 STORY ADDITION WITH NEW VESTIBULE, CANOPY AND ELEVATOR

SITE- NEW ENTRANCE PLAZA WITH UPDATED STAIRS AND RAMP, RELOCATE PLANTERS, SIGNAGE AND FLAG POLE

SITE -NEW GATHERING PLAZA WITH AT GRADE STAGE AND EXPANDED GREEN SPACE
